## Burst Tests of Filament-Wound Graphite-Epoxy Tubes

Pathfinder Test Series for Delta II GEM Motor Cases

20 December 2000

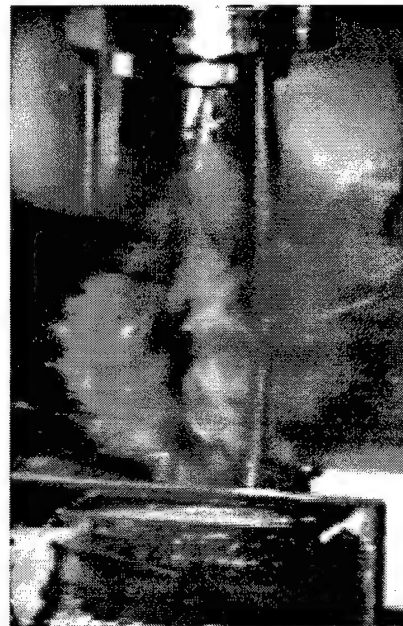
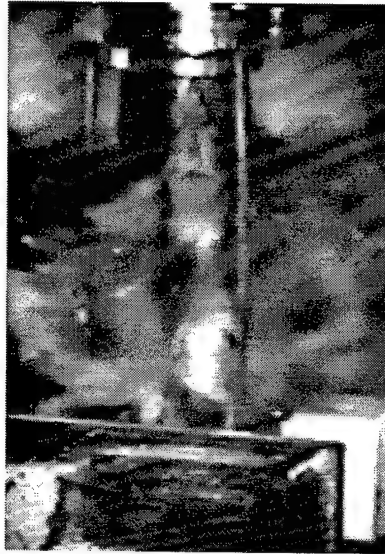
Figure 2. Failure image of mini specimen no. 4 frame #1 (initial state).

Figure 3. Failure image of mini specimen no. 4 frame #2 (0.44 ms).

Figure 4. Failure image of mini specimen no. 4 frame #3 (0.88 ms).

Figure 5. Failure image of mini specimen no. 4 frame #4 (1.32 ms).

Figure 6. Failure image of mini specimen no. 4 frame #5 (1.78 ms).

1. The failure mode of specimens tested with an inert propellant insert, whether local initial damage existed or not, was always a line crack in the axial direction caused by the hoop stress. This is demonstrated by the high-speed camera images. Figures 2 through 6 depict sequential high-speed camera images starting from the beginning of the failure for tube no. 4. The images were taken at 2250 frames per sec. A longitudinal line cut, 0.25-in. long by one-ply deep, is visible between two white dots made using "liquid paper." In Figure 3, the crack widened after 0.44 ms. In Figure 4, the composite layers were blown out and a hole formed in the inert propellant. Figures 5 and 6 show that the hole in the inert propellant resulting from the tube rupture moved upward.
